Black Slough Reach Restoration Project Community Workshop

September 10th, 5:30 p.m.
Van Zandt Community Hall

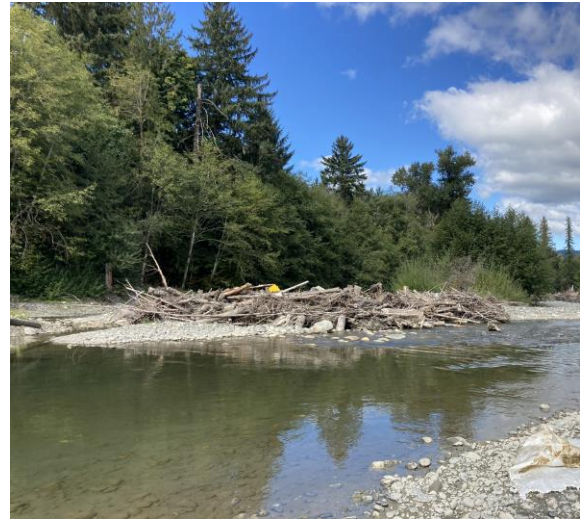
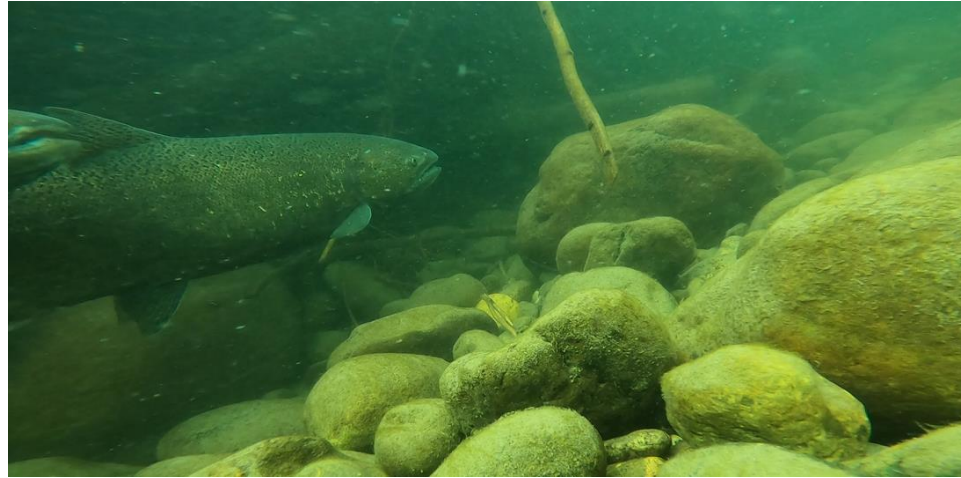
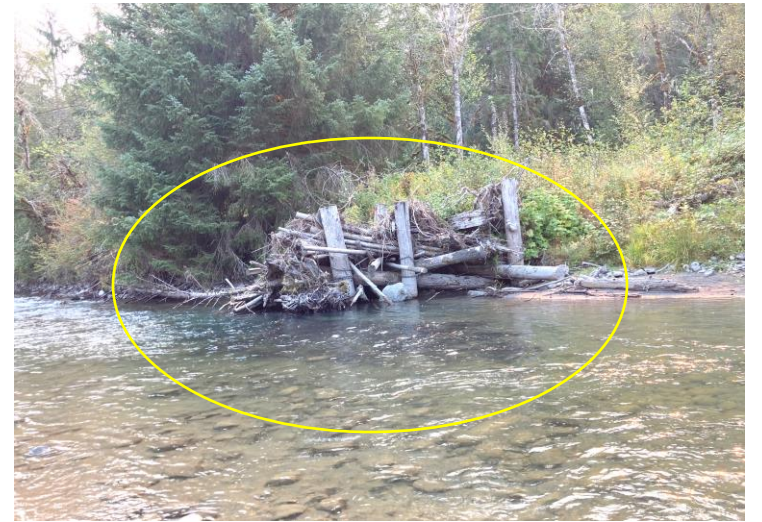
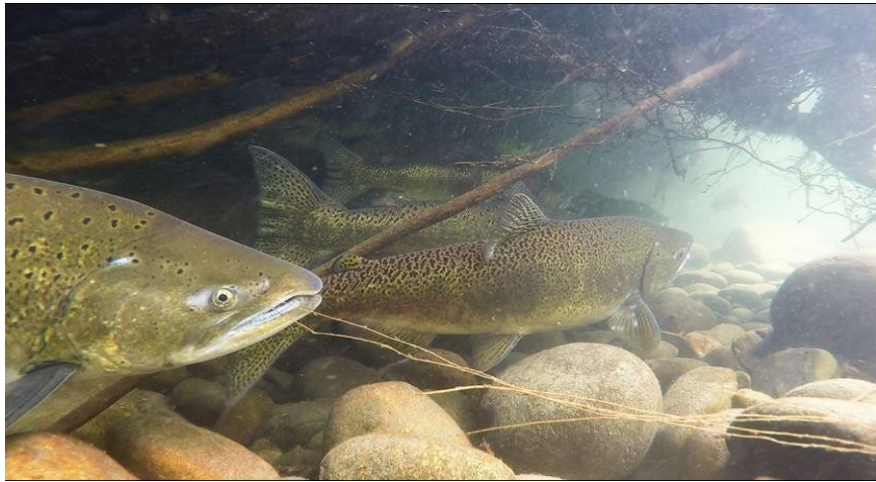
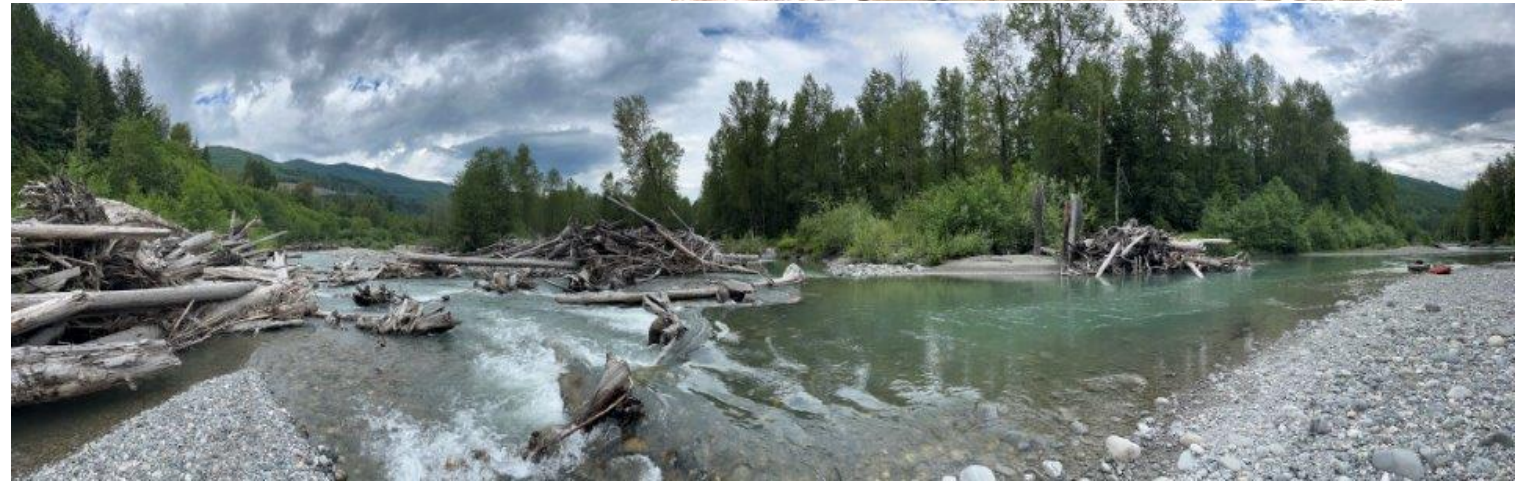
1. CREATE OR ENCOURAGE A VARIETY OF TYPES OF POOLS

The project will restore the SF Nooksack Black Slough Reach by installing a series of engineered log jams (ELJs), while exploring other restoration alternatives.

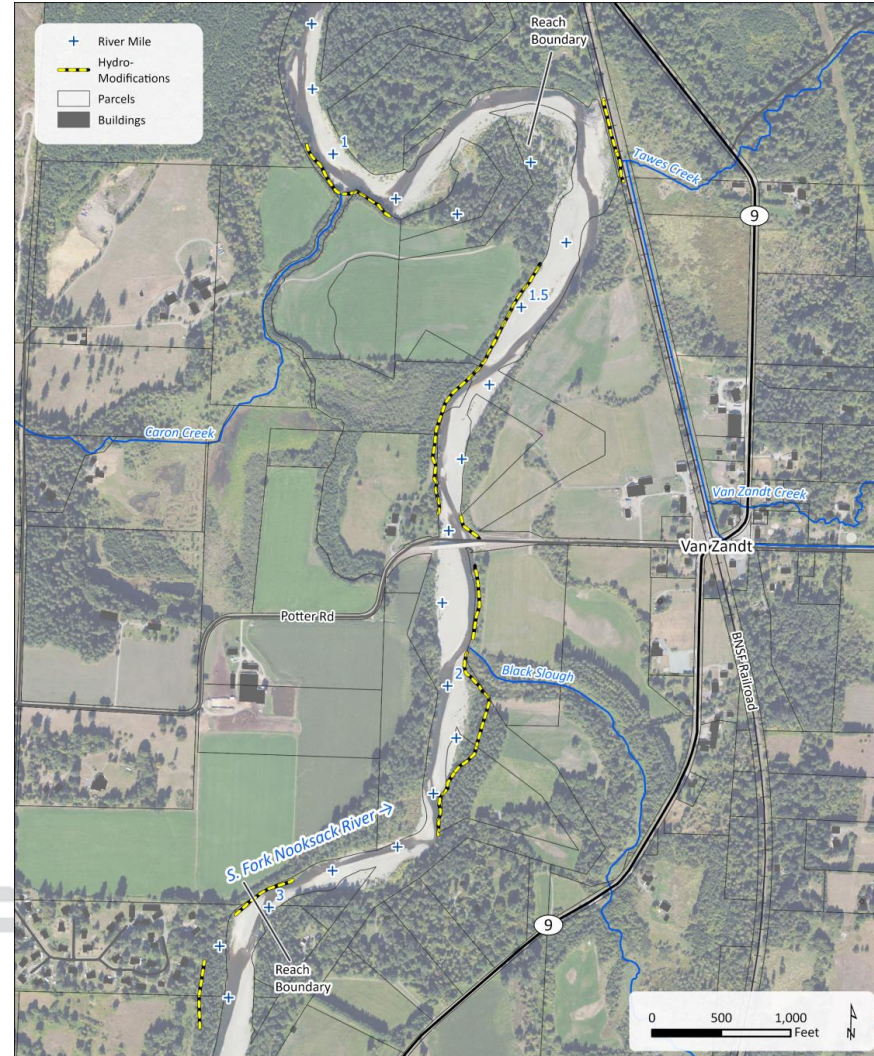
- Field Reconnaissance
- Topobathymetric Survey
- Sediment Sampling
- Evaluation of Historical Channel Change
- Influence of Bank Armoring
- Presence/function of Large Wood

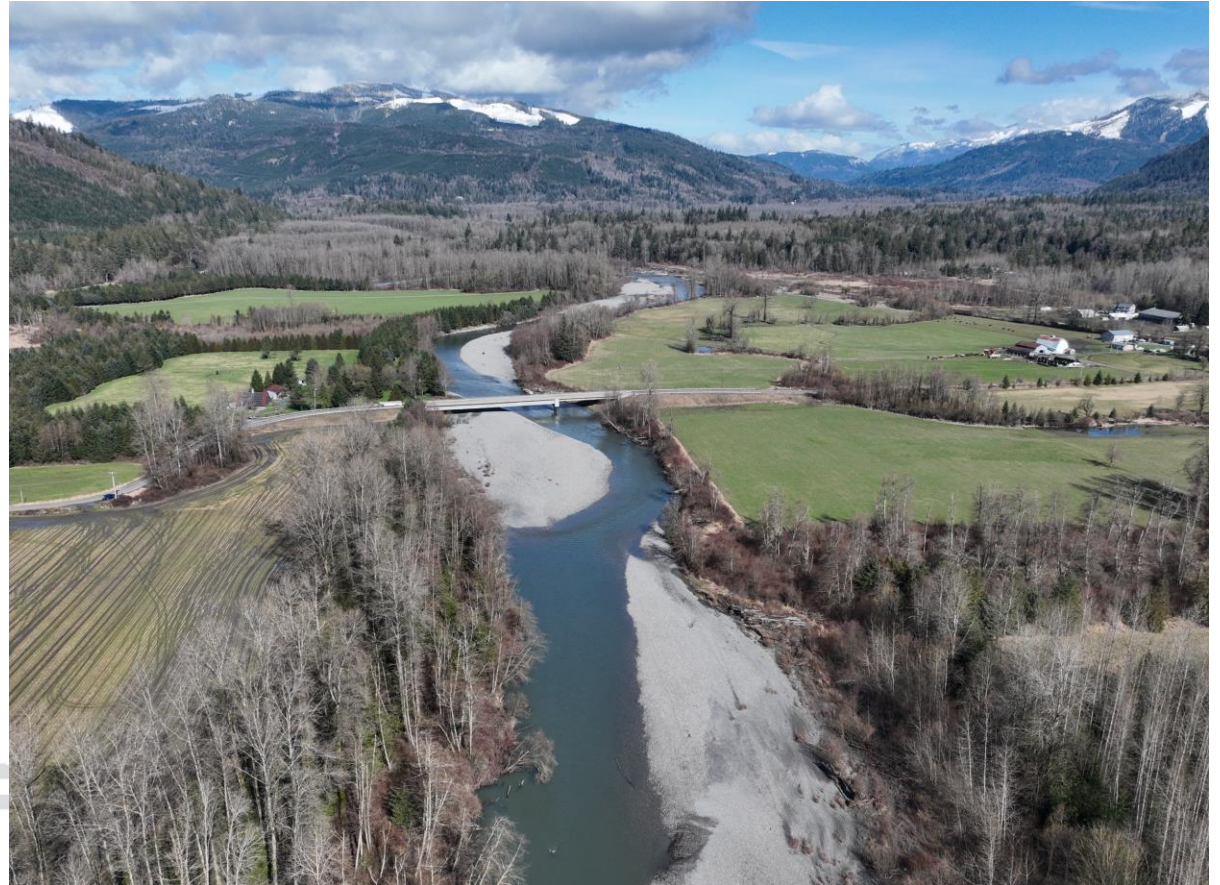
- Historical logging and floodplain clearing of large trees
- Removal of instream wood and logjams
- Bank armoring with riprap revetments installed
- Results in simplification of channel form and profile, reduced sinuosity and loss of habitat complexity

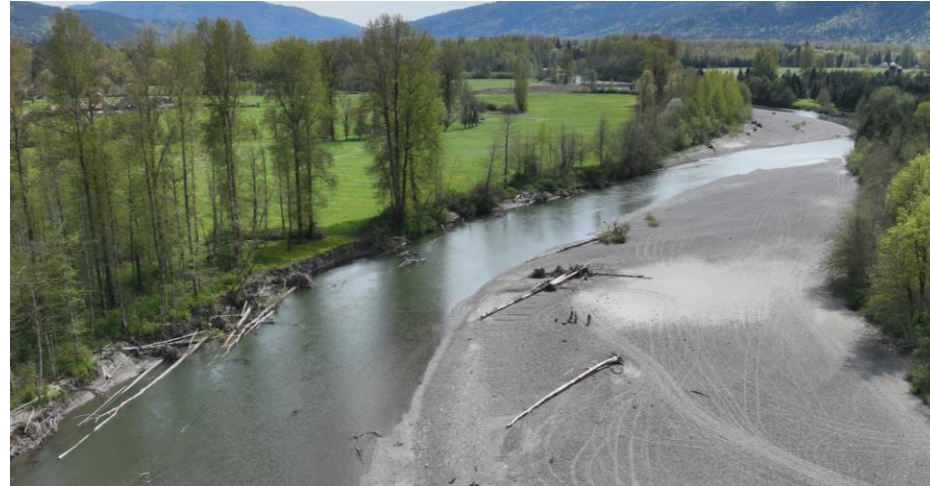
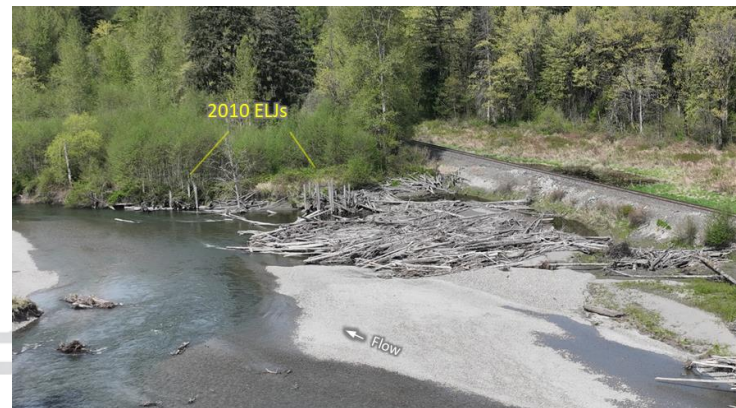
Large Wood

- Wood quantity is order of magnitude less than expected in unimpaired forested valley
- Primarily unstable bar top wood with limited habitat benefit
- Logs large enough to qualify as Key Piece capable of inducing wood jams are largely absent
- Locally, trees recruited to channel have formed pools but are not stable over time
- Previous actions include ELJs and piles to stabilize existing wood

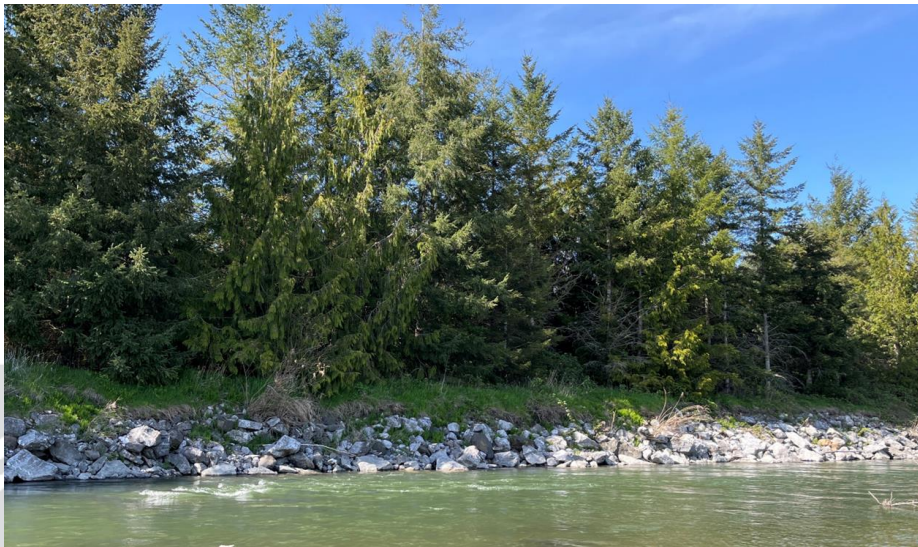
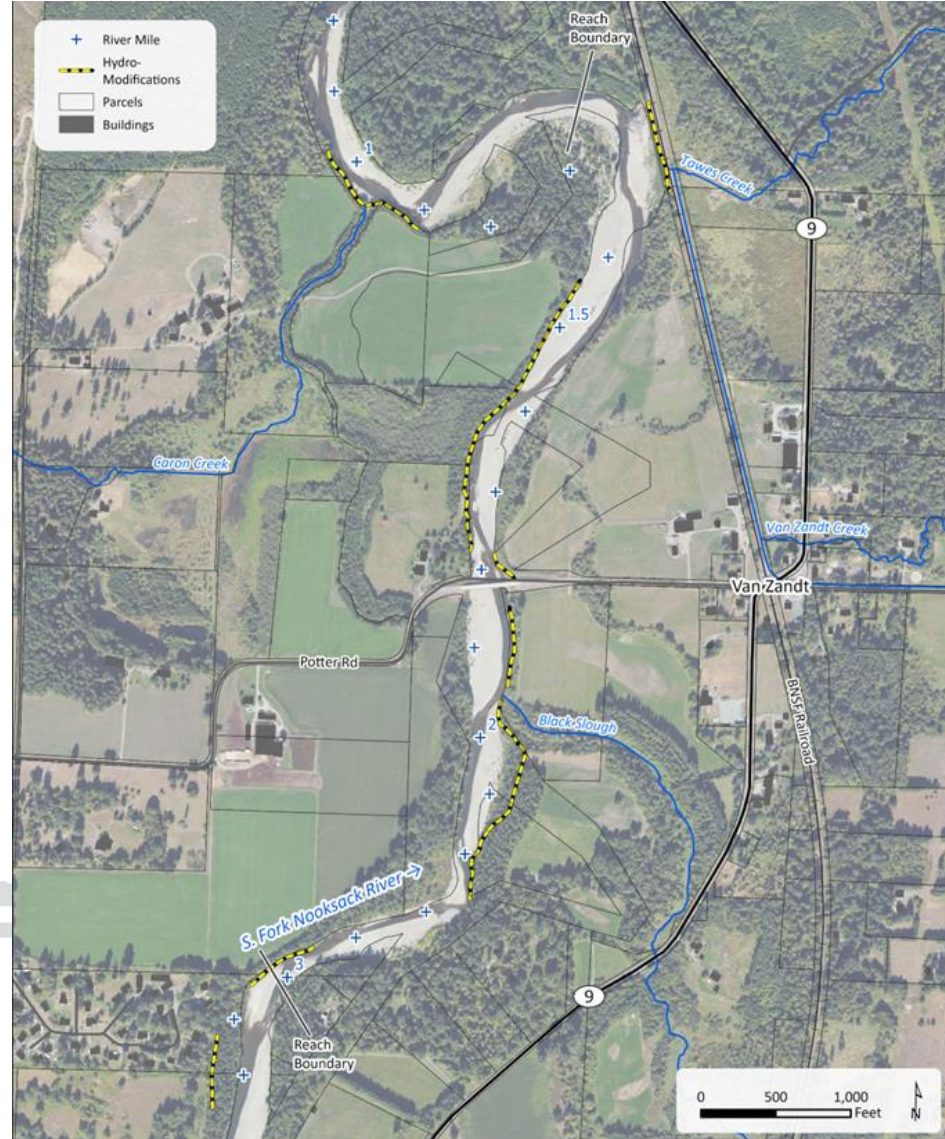
- >50% of Channel with Riprap
- Recent washouts
- Localized bank armor sloughing

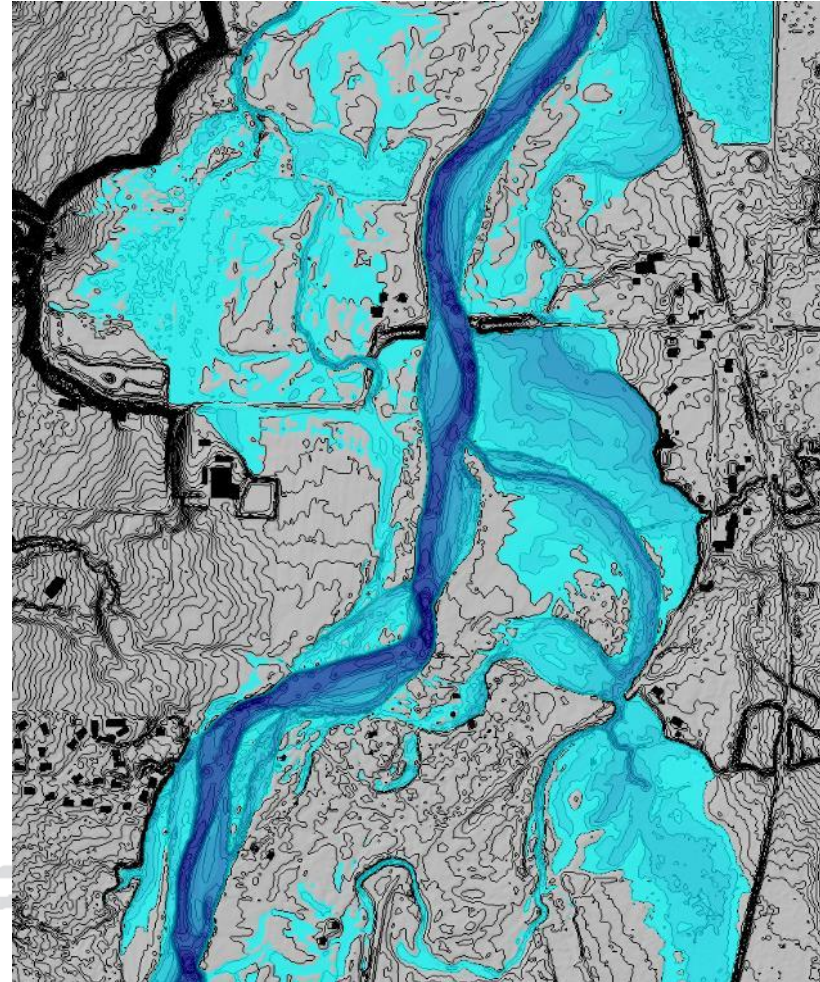
Hydrology & Hydraulics – Model Development

■ Model Topography

- ▶ Composite surface with multiple inputs
 - ▶ Most recent LiDAR (floodplain surfaces)
 - ▶ Bathymetric survey
 - ▶ UAV-generated DSM

■ Model Extent

- ▶ ~3.8 miles along mainstem
- ▶ Covers entire valley bottom
- ▶ Focuses on mainstem and floodplain (not tributaries)
- ▶ Multiple tributary drainages
 - ▶ Used 5 inputs
- ▶ Multiple Hydraulic Structures
 - ▶ ~18 included in model
 - ▶ Several more possible structure locations ignored for now

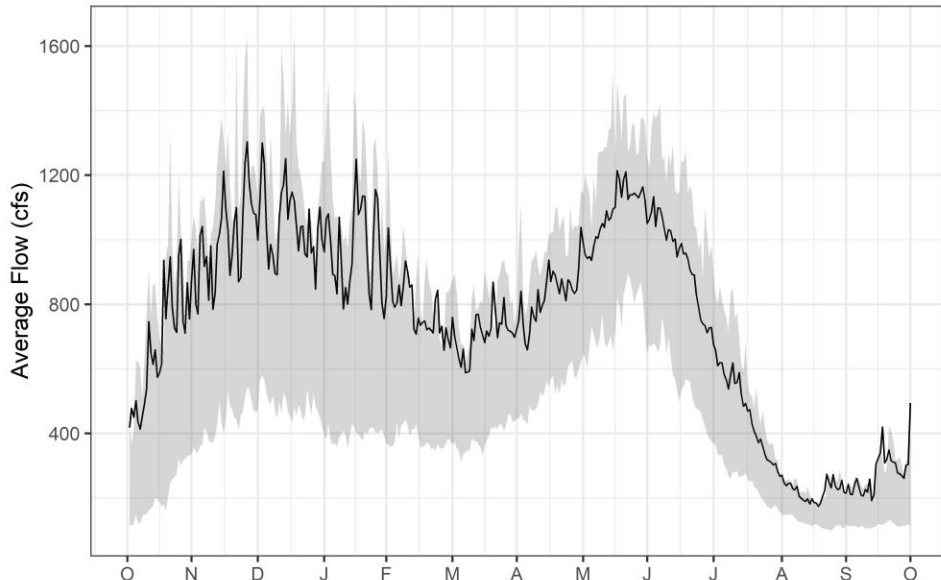
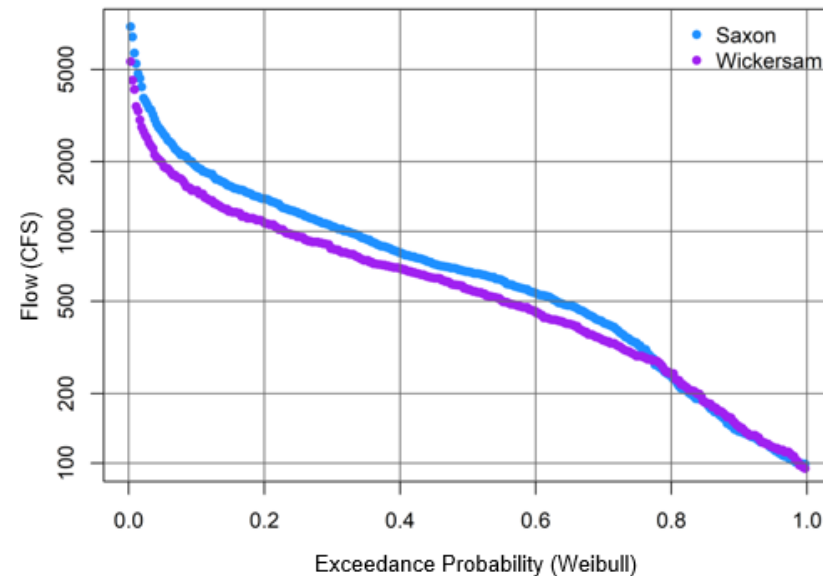
■ Streamflow characteristics

▶ Gage analysis (3 Gages, 1 SnoTel)

- ▶ Typical flows
- ▶ Peak flows for hydraulic modeling

▶ Previous work:

- ▶ USGS Groundwater study: mildly gaining groundwater
- ▶ LNR and NIT obs: de-watered tributaries and consistently warm temperatures

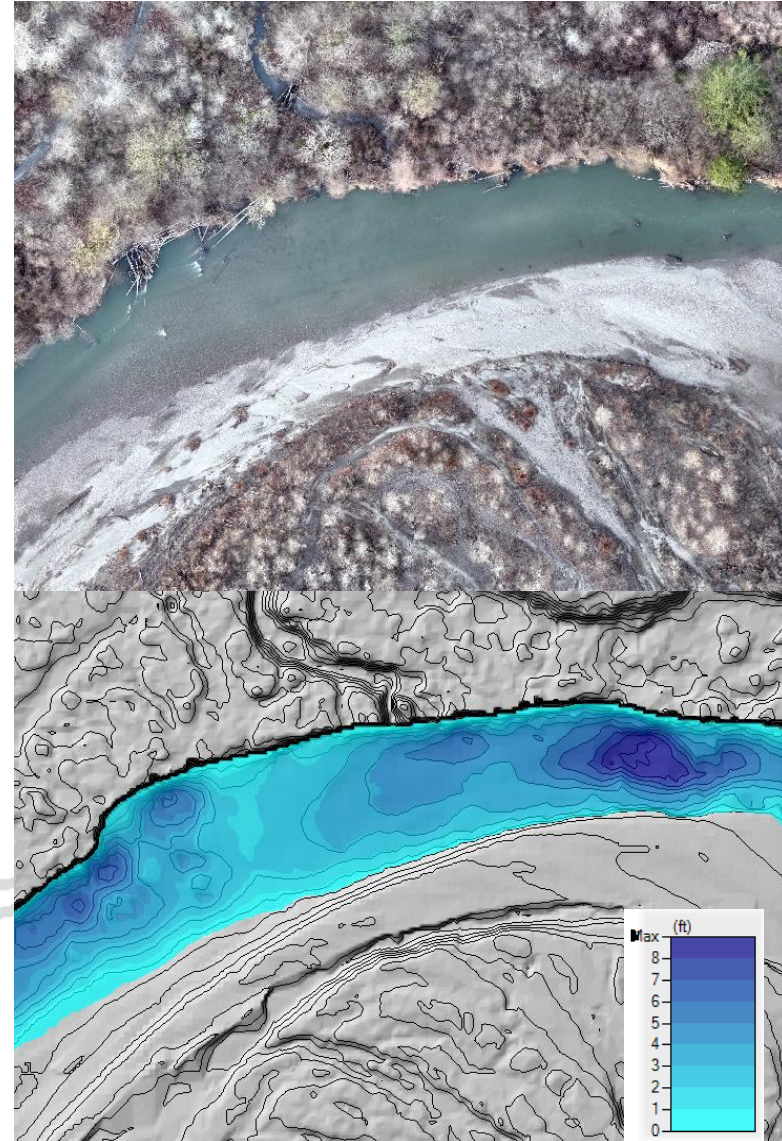
Hydrology & Hydraulics – Existing Conditions Results (Low Flow)

- Relatively constant channel width
- Active channel typically meanders between gravel bars
- Few instances of split flow or connected off-channel features
- Consistent depth and velocity
 - ▶ Depth (2-3 ft)
 - ▶ Velocity (1.5-3 ft/sec)
 - ▶ Lots of 'run' habitat
- Few pools, but typically at outside of meander bends and associated with wood

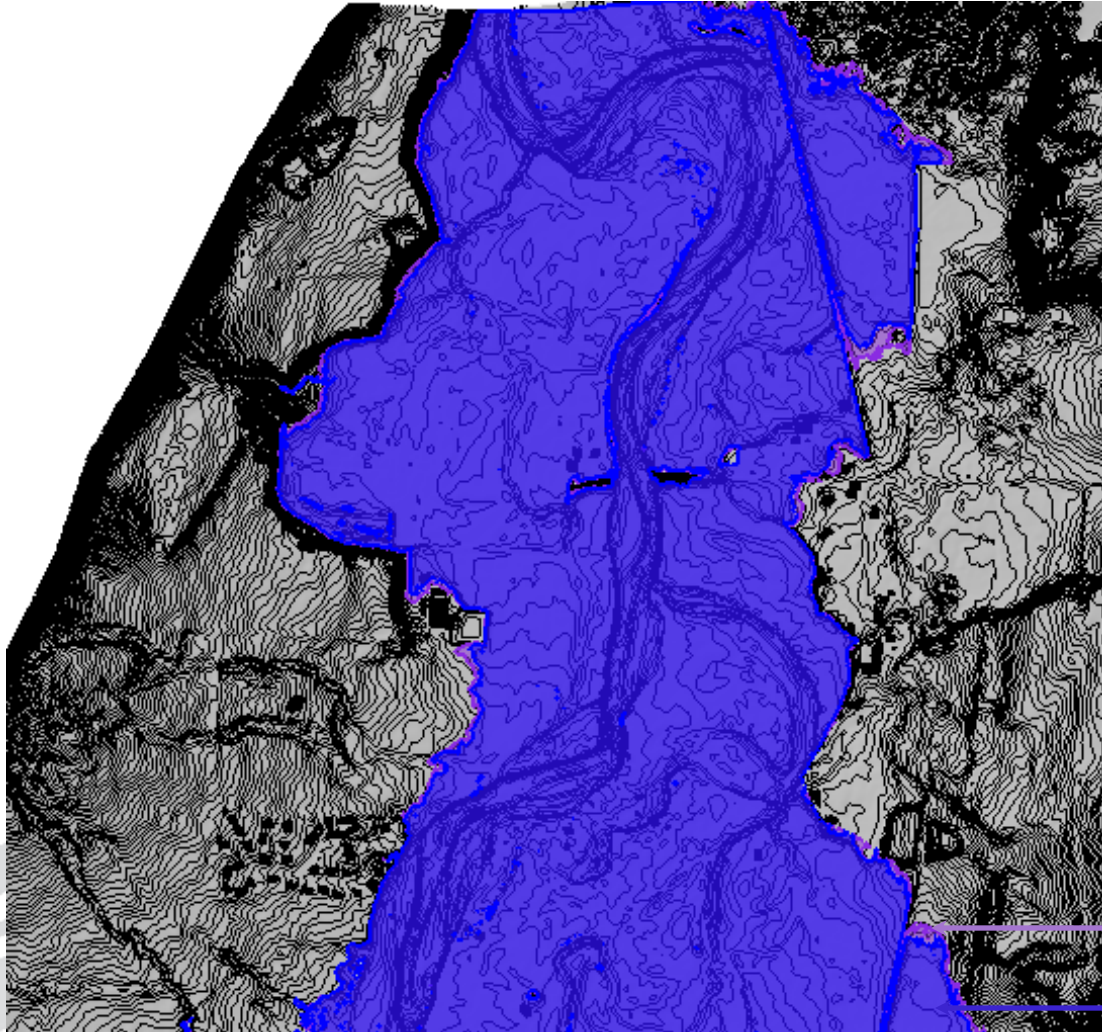
Hydrology & Hydraulics – Existing Conditions Results (10-yr and 100-yr)

- Inundation of infrastructure
- Increases in depth and velocity (more erosion and scour)
- Almost entire channel bed is mobilized
- Moderate floodplain depths (0-3 ft outside of swales/channels) and velocities (1-2 ft/sec)

Q100 Inundation

Q10 Inundation

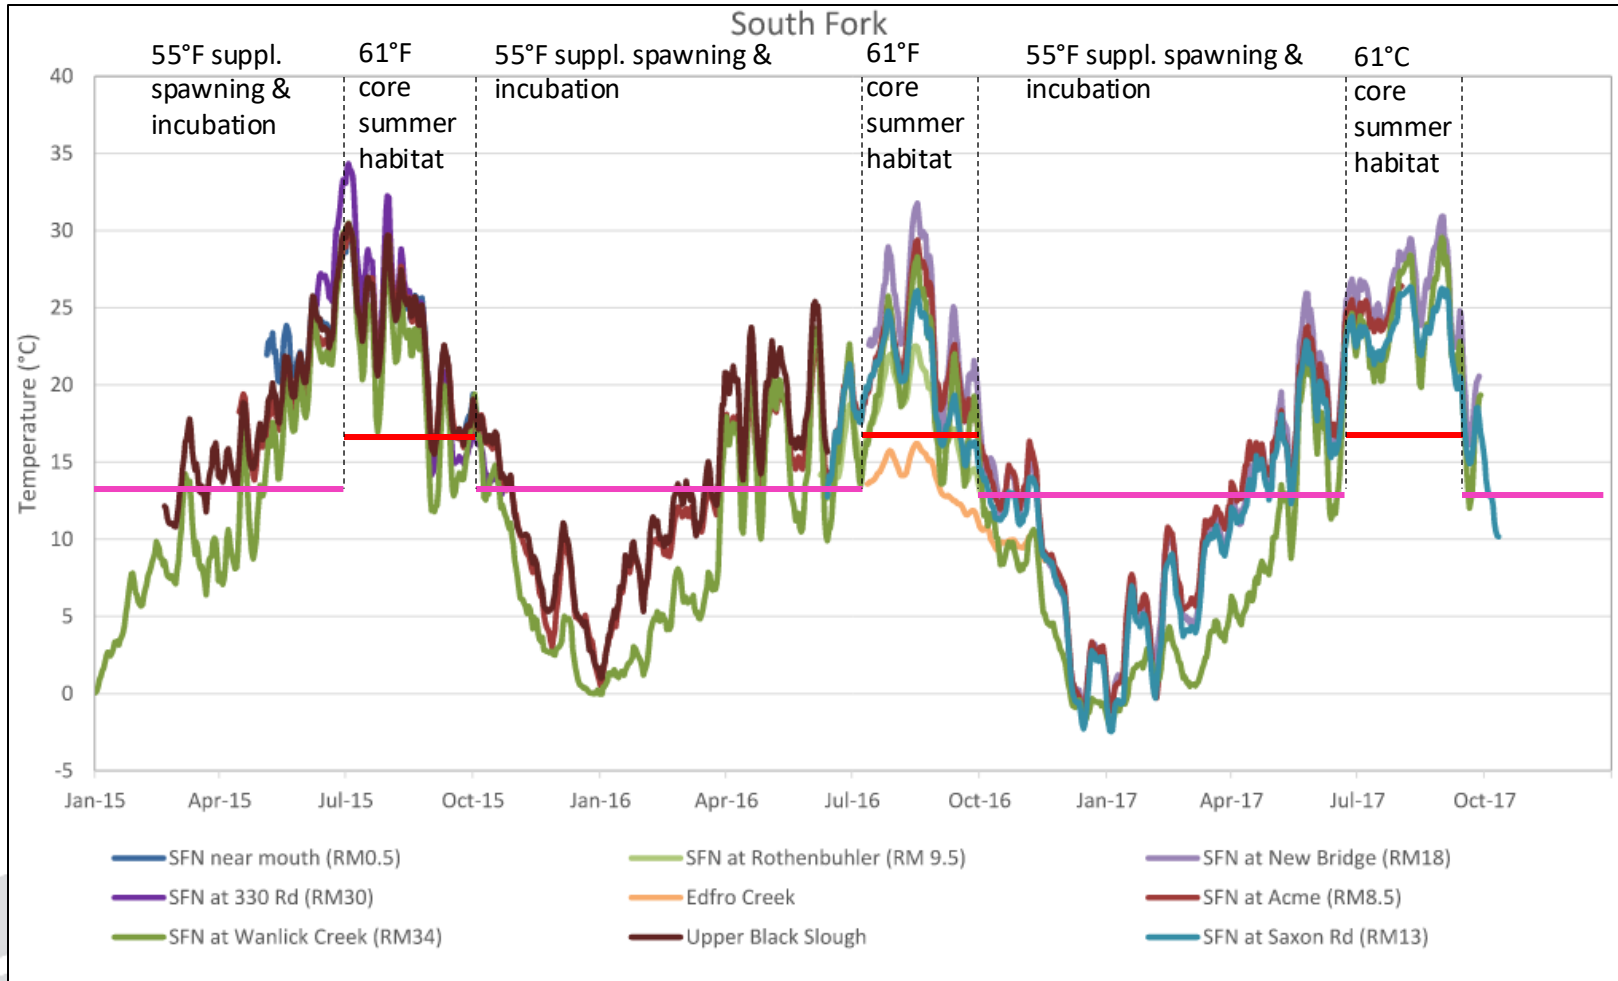
Instream Habitat Conditions – Temperature

Use Classification	Criteria	
Core summer salmonid habitat, spawning, rearing, and migration	$\leq 16\text{ }^{\circ}\text{C}$ 7-DADMax ^{a,b}	(61°F)
Char spawning and rearing	$\leq 12\text{ }^{\circ}\text{C}$ 7-DADMax ^{a,b}	(54°F)
Supplemental salmonid spawning and incubation	$\leq 13\text{ }^{\circ}\text{C}$ 7-DADMax ^{a,b} (Sept 1–Jul 1)	(55°F)

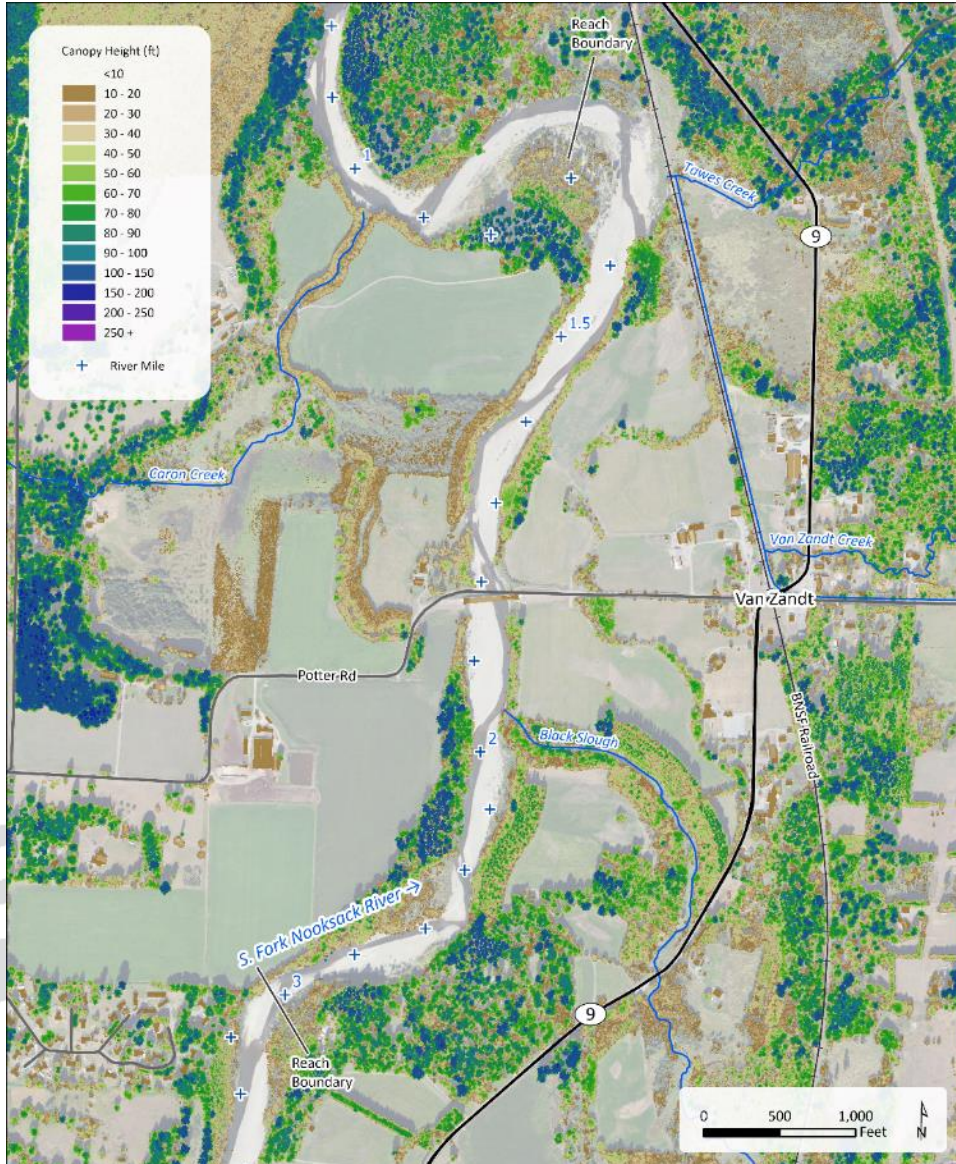
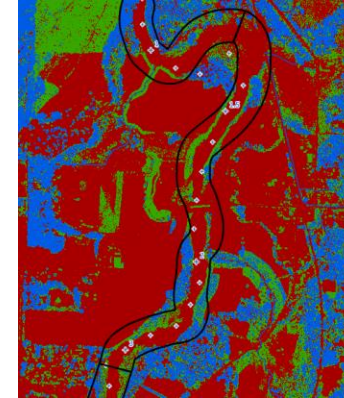
Floodplain & Riparian Conditions – Vegetation

General height distribution

- ▶ 67% <10'
- ▶ 20% 10-50'
- ▶ 13% 50-171'

(includes unvegetated areas – 300' buffer offset from generalized channel CL)

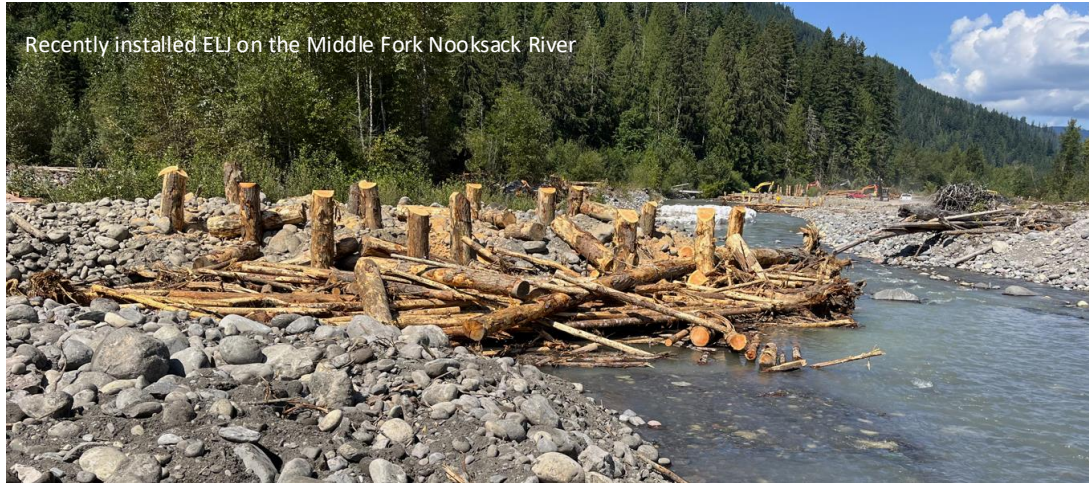
Recently installed ELJ on the Middle Fork Nooksack River

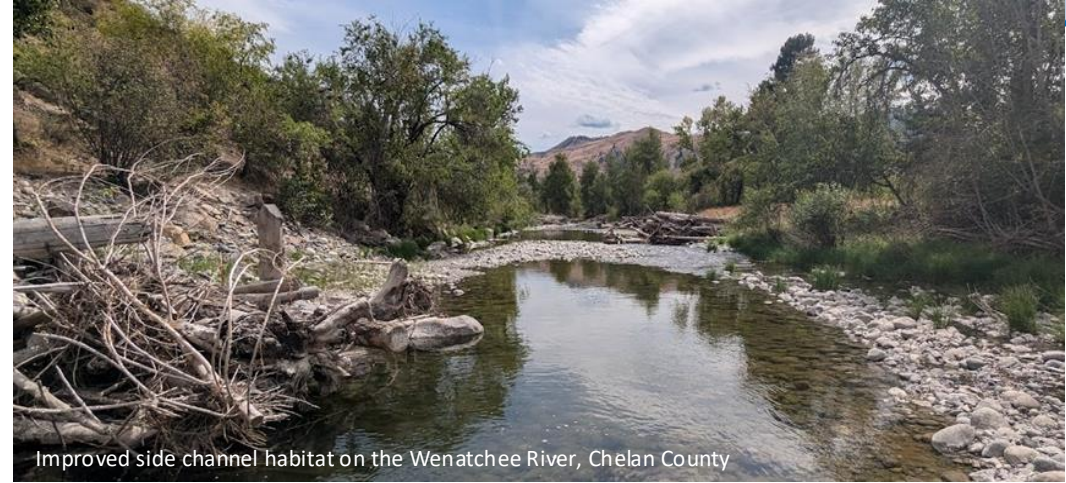
Improved side channel habitat on the Wenatchee River, Chelan County

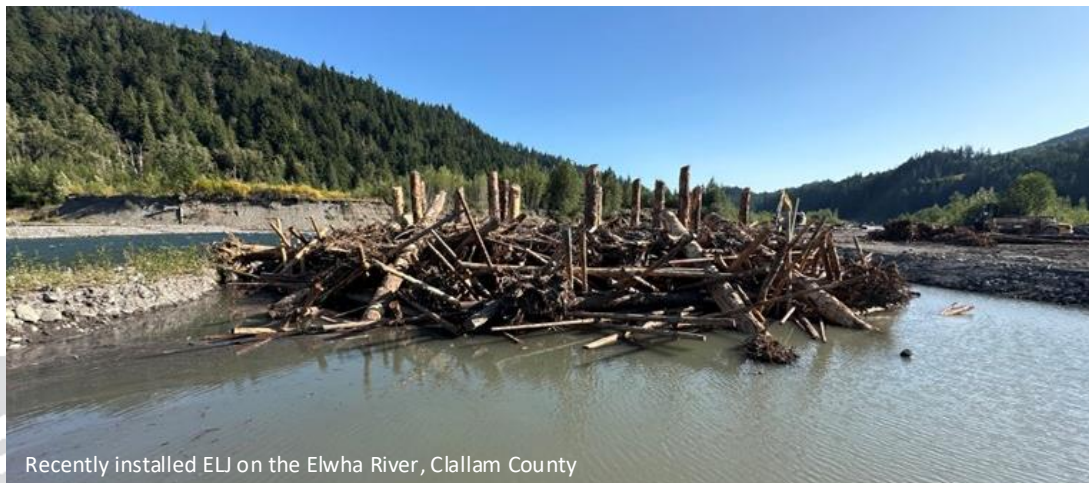
Recently installed ELJ on the Elwha River, Clallam County

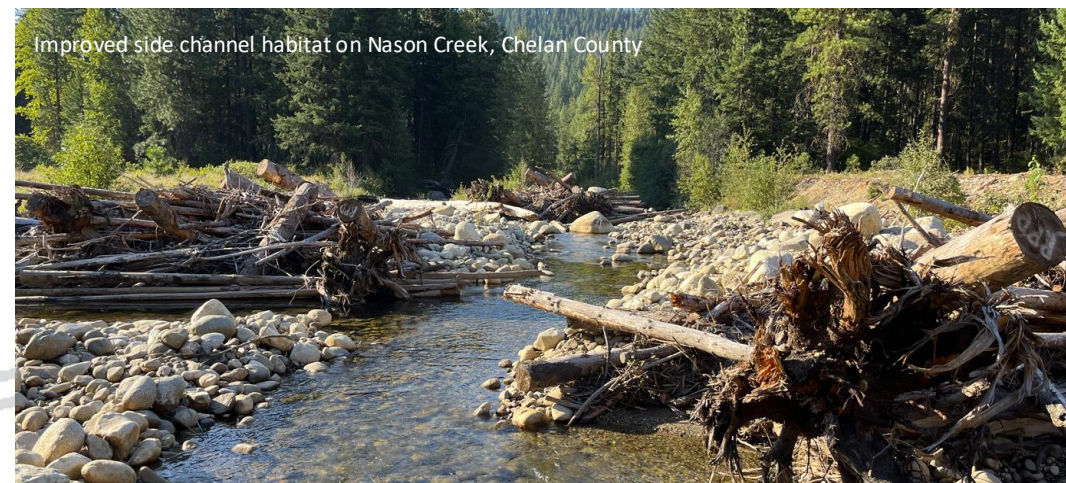
Improved side channel habitat on Nason Creek, Chelan County
