Technical Memorandum

Re: South Fork Nooksack River Skookum-Edfro Reach Phase 1 Adaptive Management
Geomorphic Assessment

1 BACKGROUND AND PURPOSE

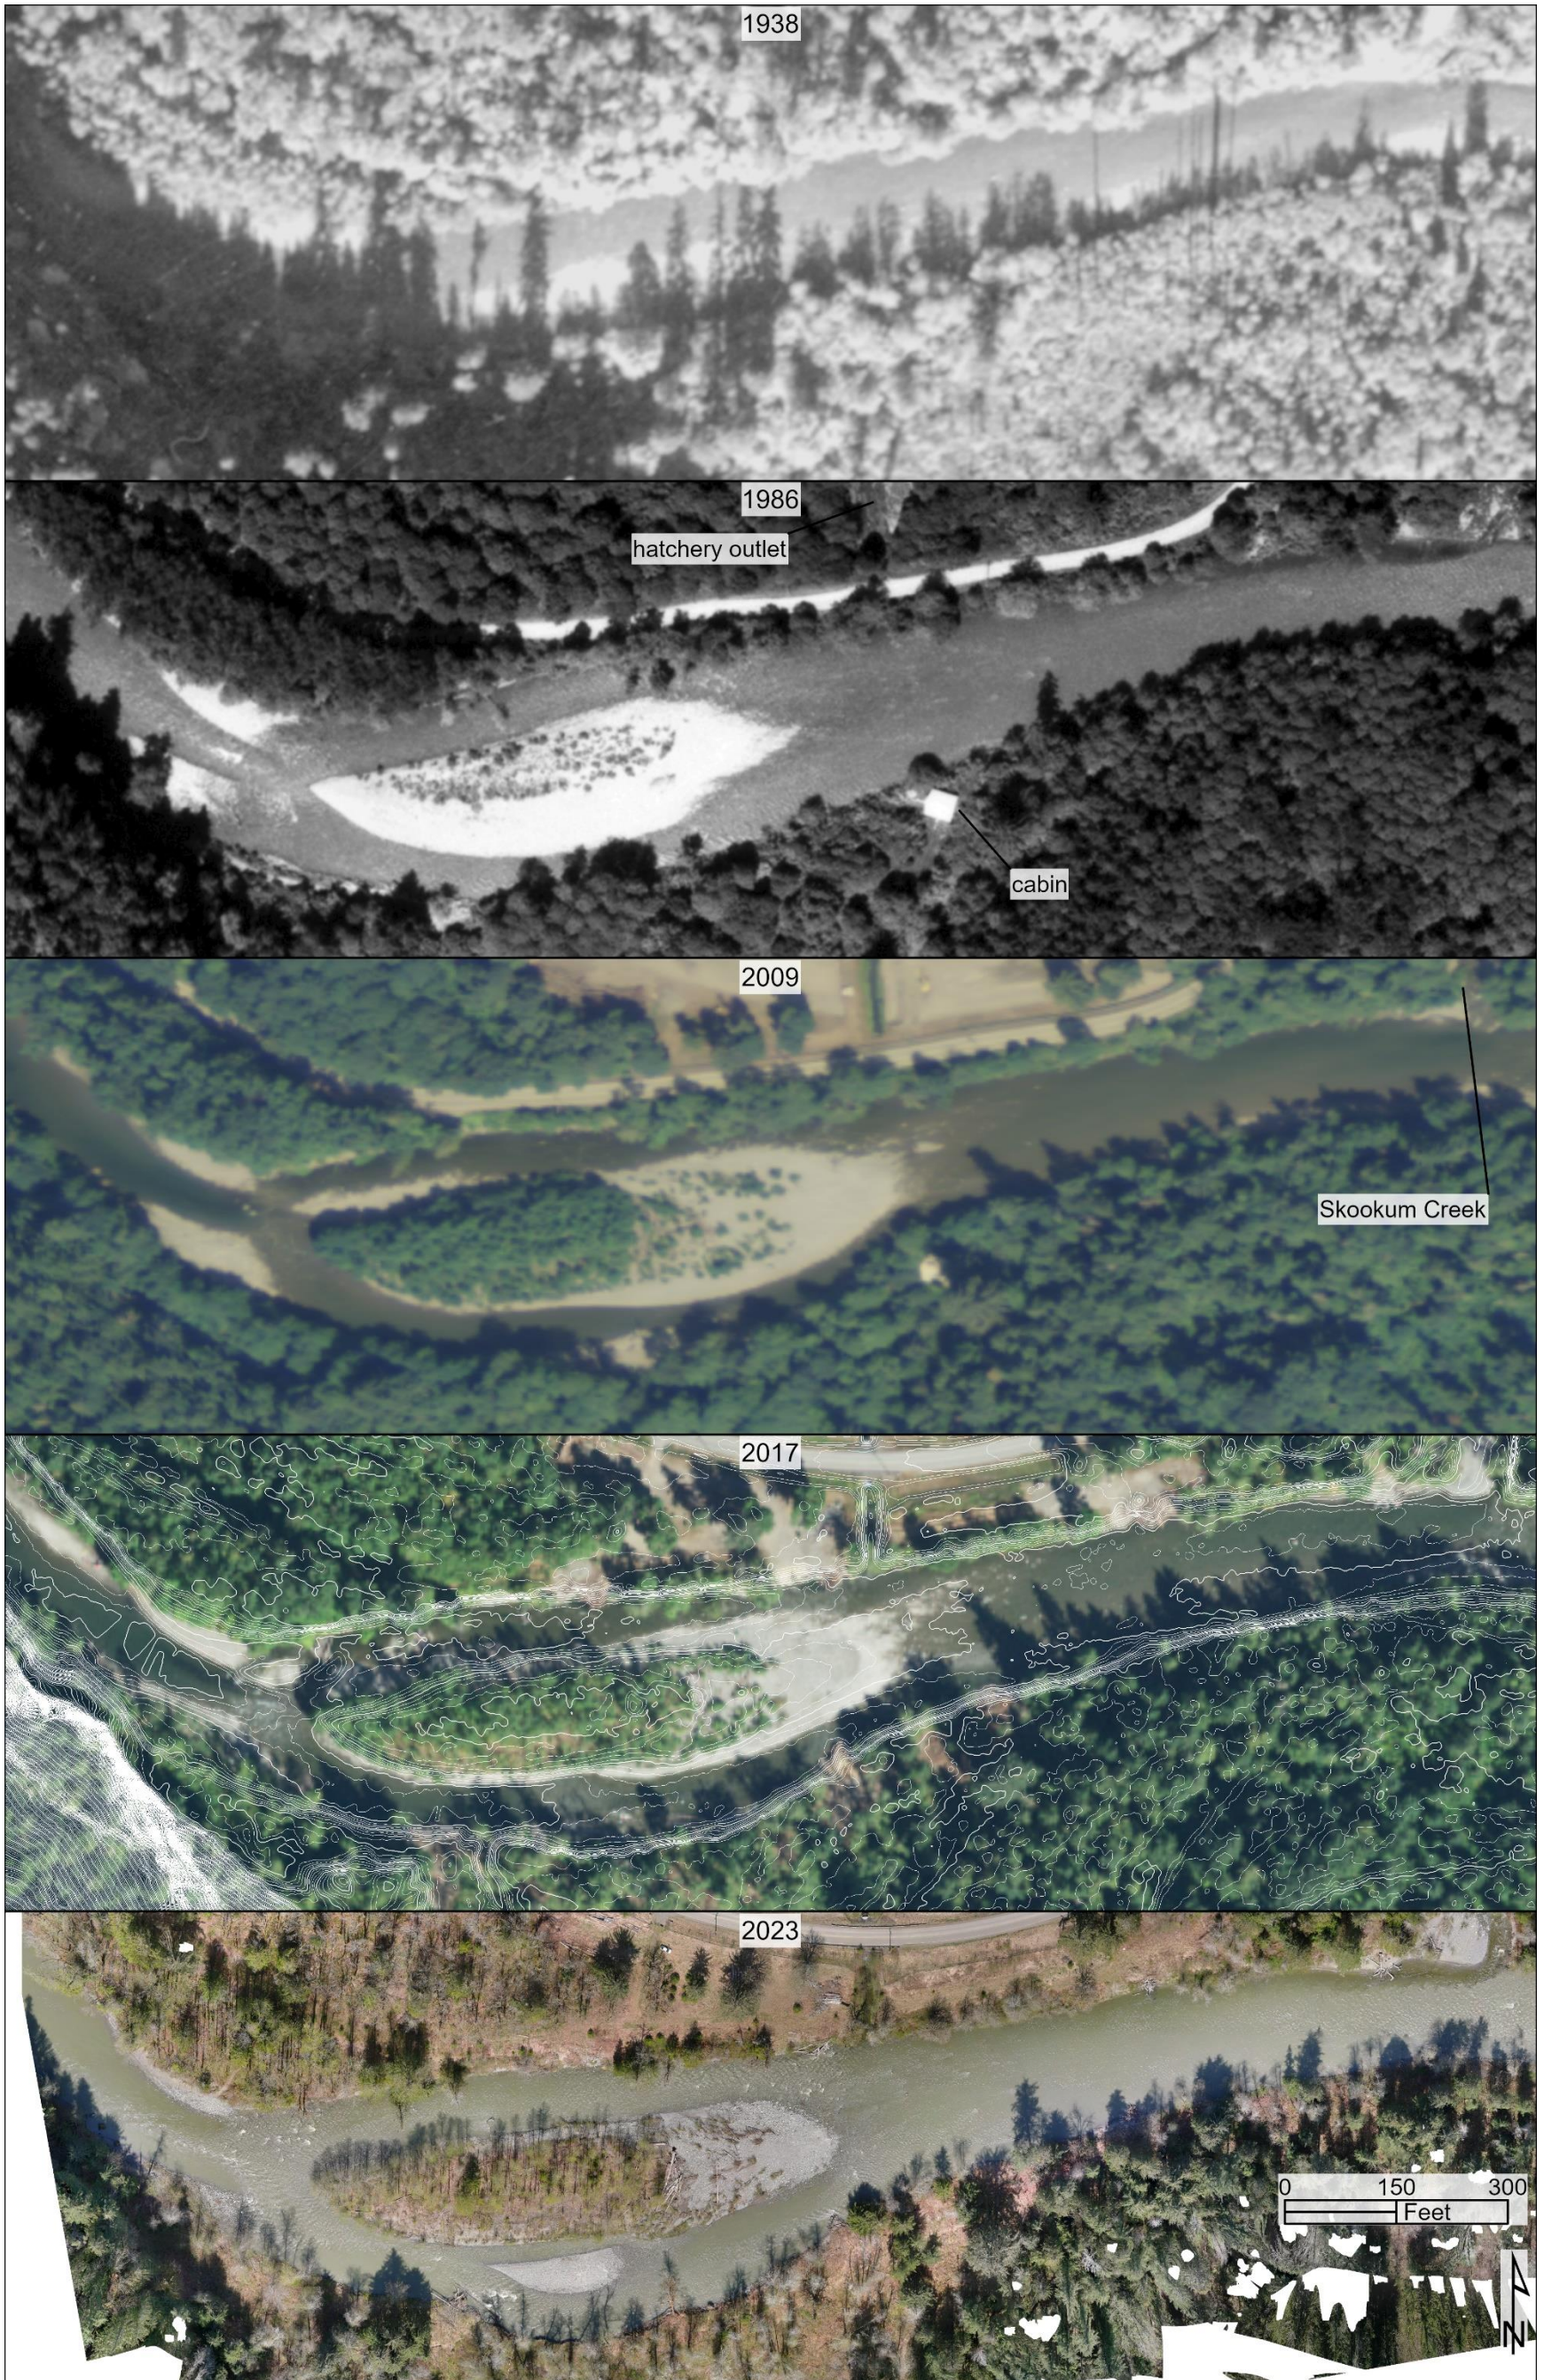
Figure 2: Historical geomorphic evolution of the project reach from 1938 to 2023. 2017 imagery has 1-ft topobathymetric contours.

- Skookum Creek, which flows into the mainstem near the upstream meander bend apex, may disrupt the normal hydraulic pattern along the right bank, reducing the river's ability to erode its right bank for some distance downstream. An example of this is illustrated in the 2023 photo shown in Figure 2: The clear water of Skookum Creek doesn't fully mix with the turbid water of the South Fork until approximately 300 ft downstream of the confluence, at a discharge of 1,700 cfs in the South Fork (larger than the average annual flow rate, but less than the 2-year flow event). Examination of the two-dimensional (2D) hydraulic model results of the existing condition (i.e., the pre-Phase 1 Adaptive Management project conditions) showed a significant reduction in flow velocity near the bank extending down to the second 2010 ELJ (approximately RM 14.2) from the Skookum Creek confluence, indicating a likely suppression of bank erosion provided that Skookum Creek floods coincidentally with the South Fork.

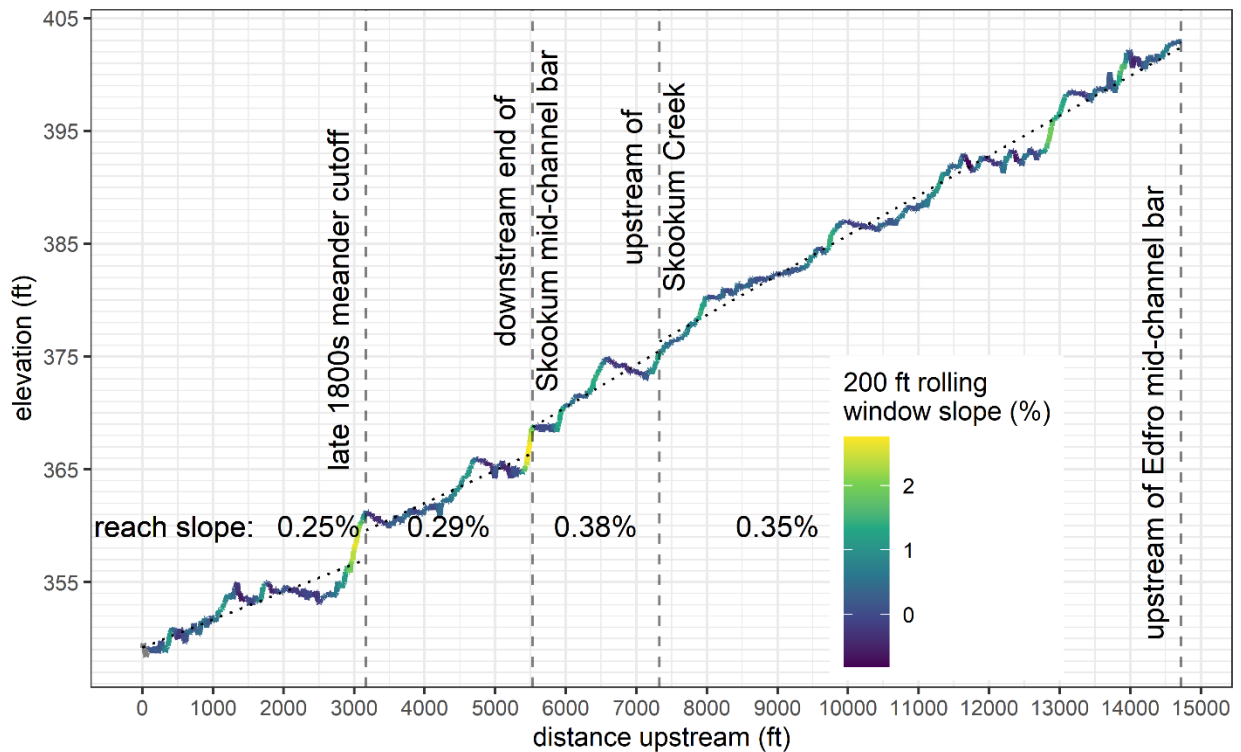
Figure 6: Longitudinal thalweg profile (alignment shown in Figure 5) from Saxon Bridge (downstream) to the upstream end of the Edfro mid-channel bar. Reach-average slopes are shown as dotted lines for each reach.

In the South Fork's longitudinal elevation profile (Figure 6), we observe two unusually steep drops that could correspond to headcut incision from the pre-1884 meander bend cutoff. The first is approximately 3,000 feet downstream of the hatchery near the site of the meander cut off. It may not have eroded very far since it formed over a century ago. The second is at the downstream end of Skookum Island. Based on headcut steepness and well log boring near the fish hatchery that shows bedrock at elevations just below the channel bed, we hypothesize that both headcuts have been slowed by erosion-resistant bedrock.
